## Service Bulletin

SEB94-8

HORIZONTAL STABILIZER FORWARD SPAR INSPECTION/MODIFICATION

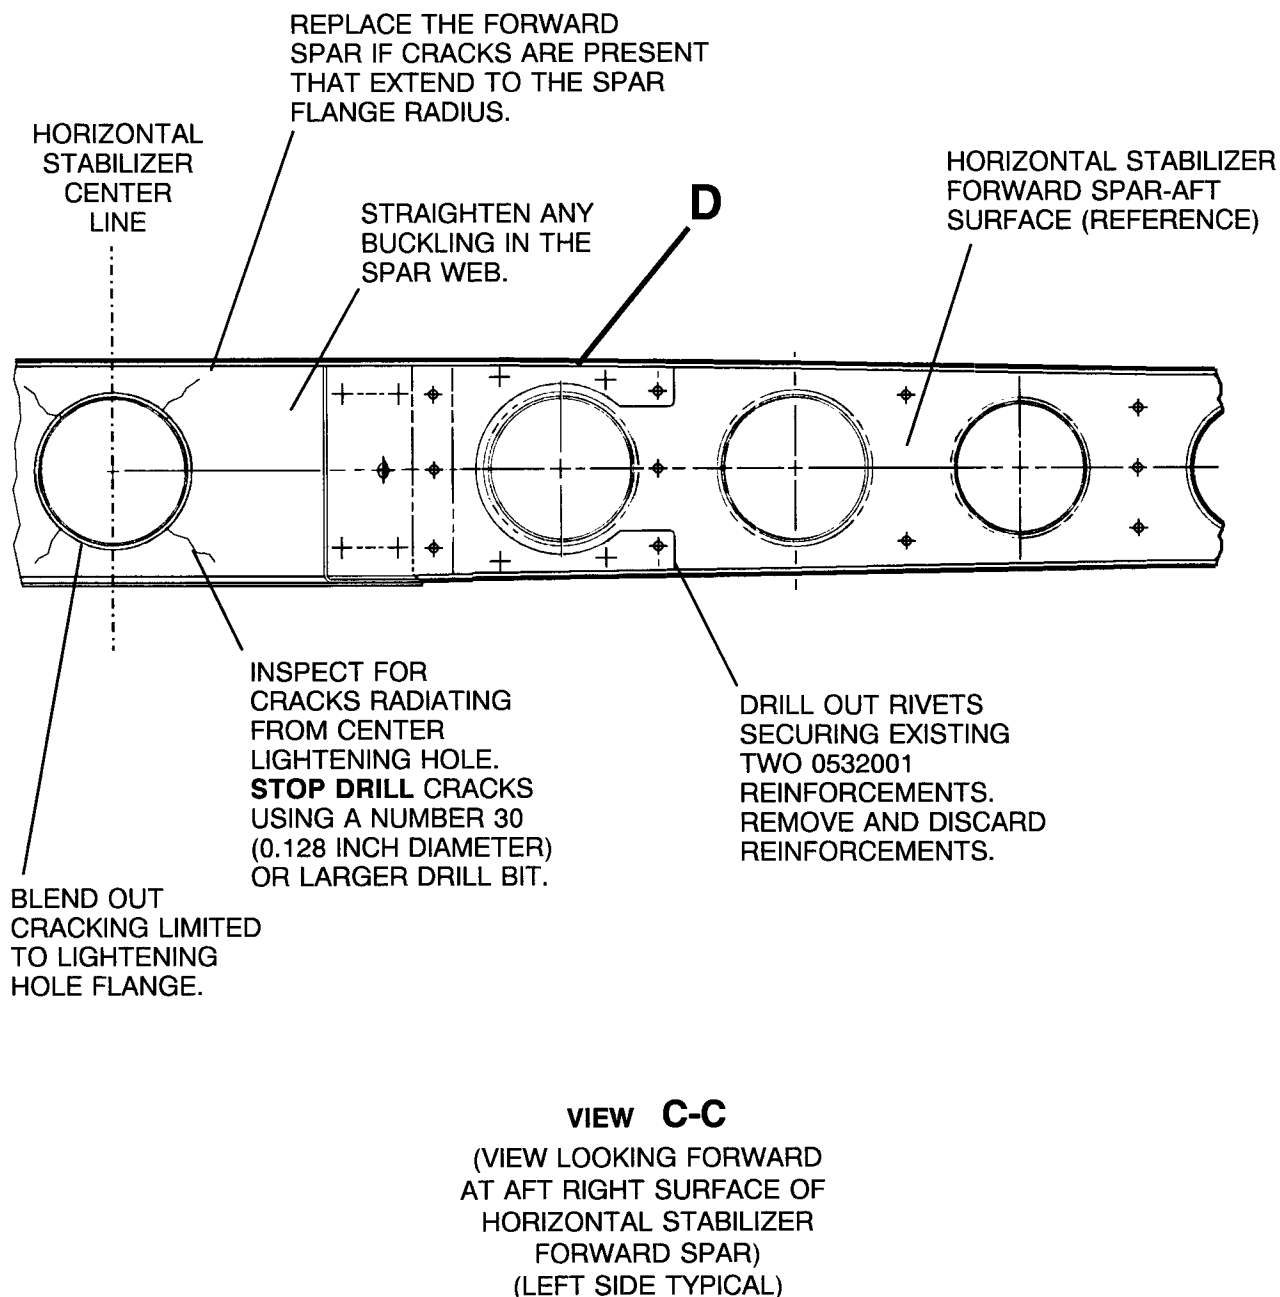
Figure 1. Horizontal Stabilizer Forward Spar Inspection/Modification (Sheet 3)

(1) (Refer to Figure 1, Sheet 3, View C-C.) From the aft side of the horizontal forward spar, examine the centerline lightening hole for cracks. Cracks will generally radiate diagonally from the lightening hole.

(2) If cracks are present:

(a) Cracks that have not progressed past the centerline lightening hole flange may be blended out.

(b) Cracks that have progressed past the centerline lightening hole flange but do not extend to the spar flange radius, stop drill using a Number 30 (0.128 inch diameter) drill. Proceed to step 2.

(c) Cracks that have progressed to the spar flange radius, replace the spar with a 0532001-98 forward spar assembly. Refer to step 2 of these instructions and the applicable airplane service manual.

- J. (Refer to Figure 1, Sheet 3, View C-C, and Sheet 4, Detail D) Locate the new 0531037-1 one-piece reinforcement (which replaces the two reinforcements removed in step G.) Install the spar web rivets on the left side only in existing rivet locations. Deburr all holes. Providing edge distance is maintained, fasteners one size larger may be used as required to obtain good holes and fit.
