## Service Bulletin

SEB94-8

HORIZONTAL STABILIZER FORWARD SPAR INSPECTION/MODIFICATION

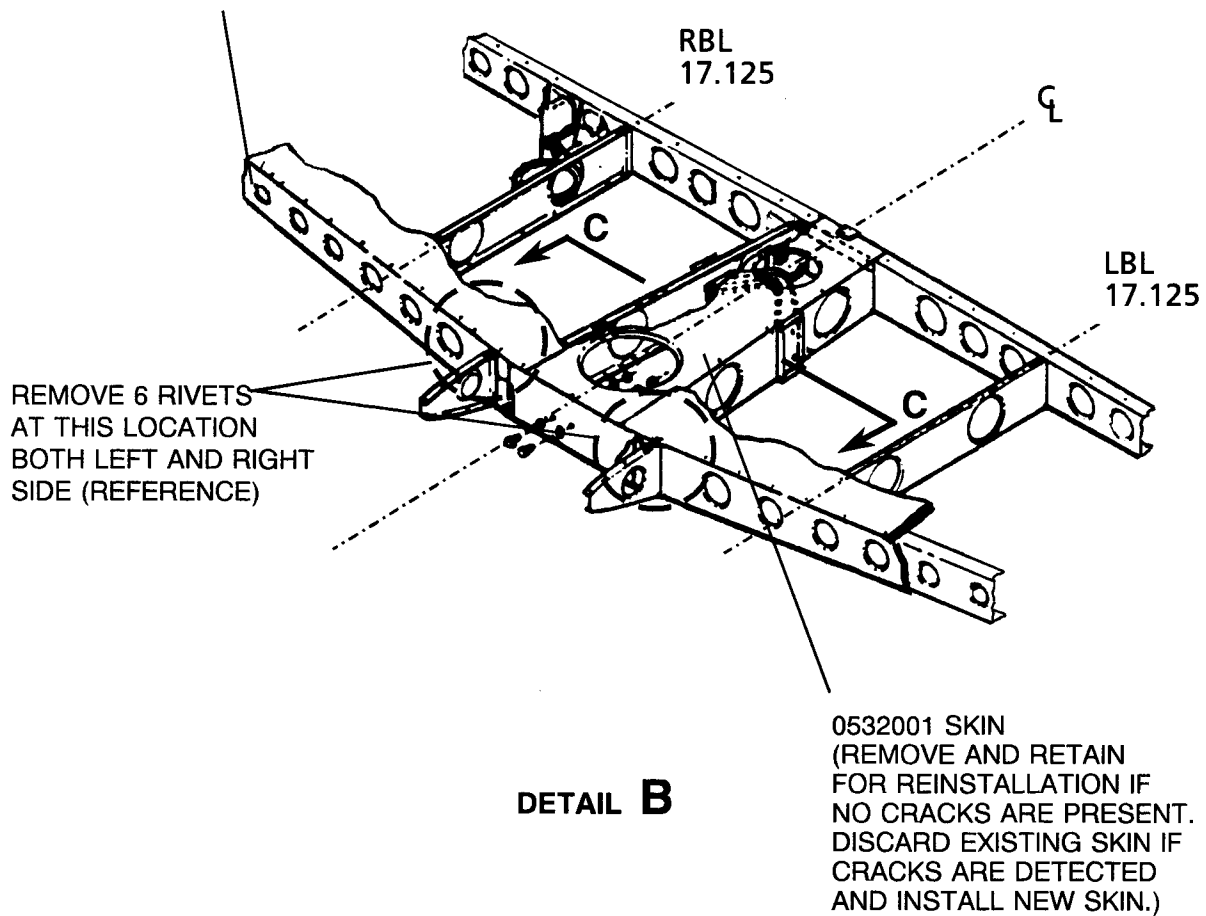
Figure 1. Horizontal Stabilizer Forward Spar Inspection/Modification (Sheet 2)

**NOTE:** LEADING EDGE  
NOT SHOWN FOR  
CLARITY ONLY.
