1956 through 1986 Cessna 182 Fixed Gear Skylane

Buyers Guide

By John Frank

1956 through 1986 182 Skylane Buyers Guide
Rev. No. 6 — 03/31/14
Copyright © 2008 by John M. Frank, Jr.

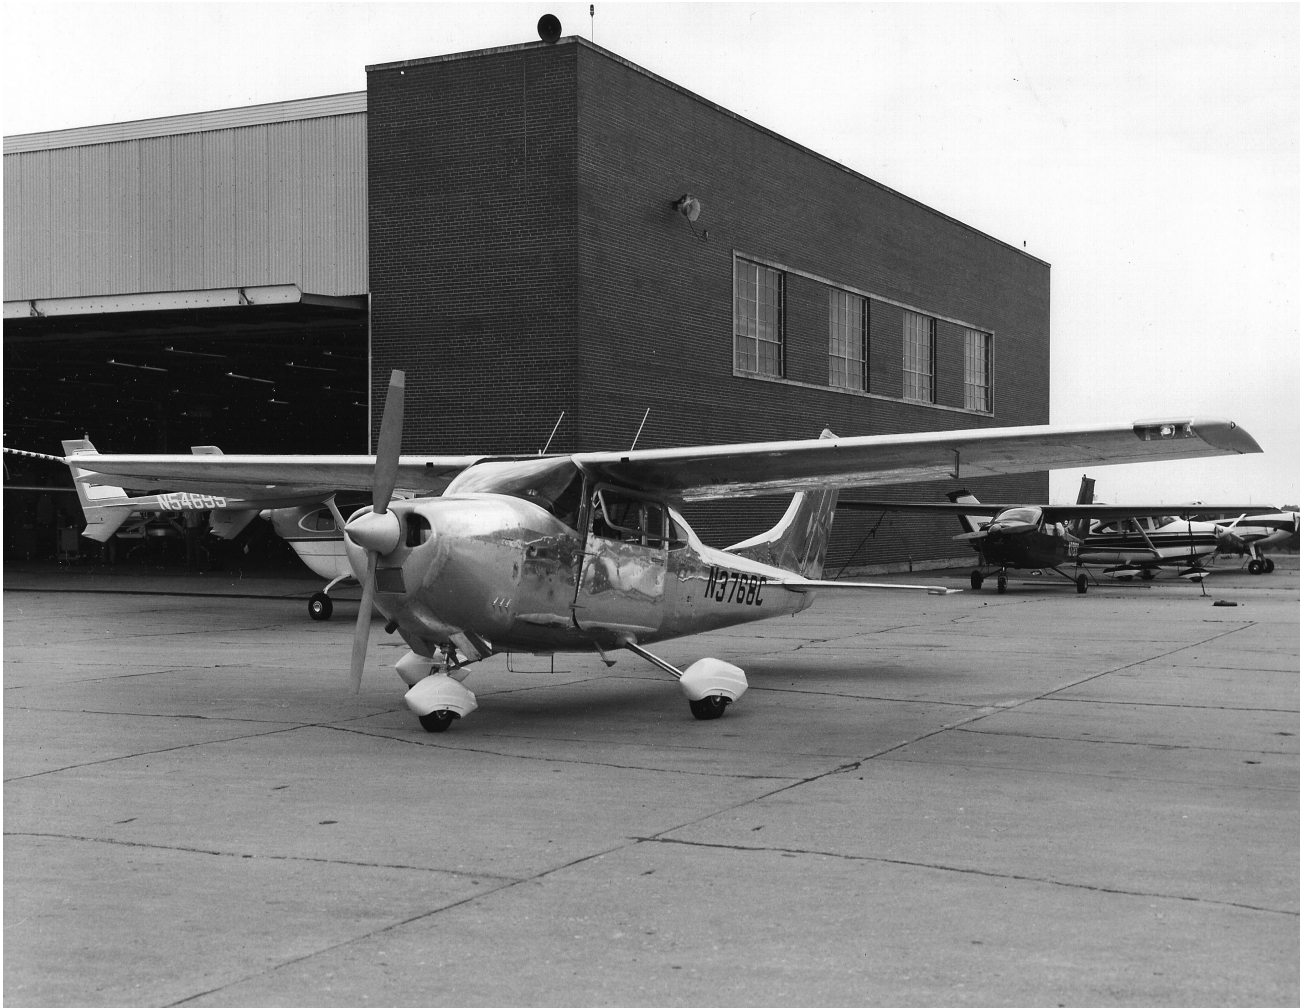
Prototype of a cantilevered wing Cessna 182M. Lack of performance improvement lead the factory to decide not to put a cantilever wing 182 into production.

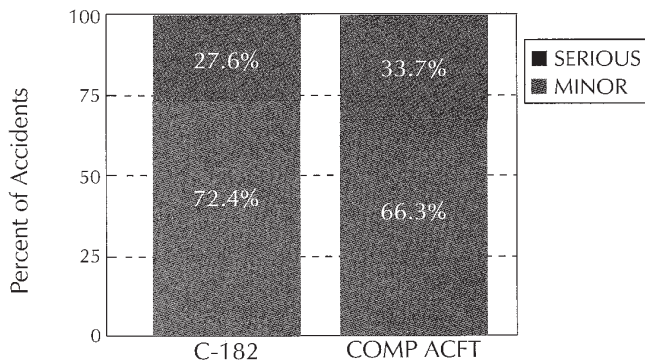
Figure 1. Accident Summary C-182

SERIOUS	363	1017
MINOR	951	2005

Almost three-quarters, or 72 percent, of Cessna 182 accidents were minor, resulting in little or no injury, while two-thirds, or 66 percent, of the comparison aircraft accidents were minor. (See Figure 1). Accidents resulting in serious injuries, as defined by NTSB Part 830, make up the smaller portion of the accident number. The Skylane had fewer serious accidents than the comparison group. This may be due to the Skylane being used for cross-country trips, while the majority of accidents in the comparison group involved PA-28s, which are used primarily as trainers. Trainers participate in more takeoffs and landings, which is when most accidents occur.

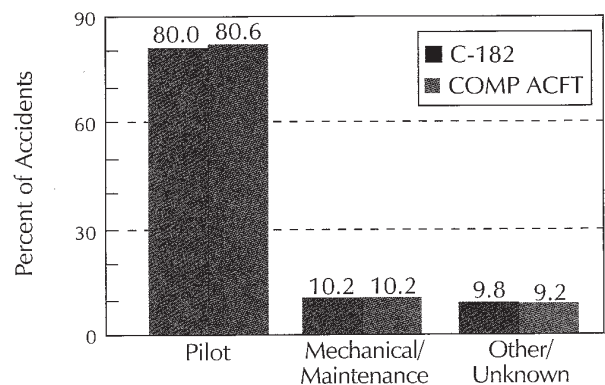
Figure 2. Major Cause C-182

C-182	1051	134	129
COMP ACFT	2436	308	278

As expected, the majority (80 percent) of Cessna 182 accidents were due not to aircraft problems, but to pilot error. Mechanical/maintenance problems caused only 10 percent of the Skylane accidents, and the remaining 10 percent were at-

tributed to other causes and unknown factors. (See Figure 2).

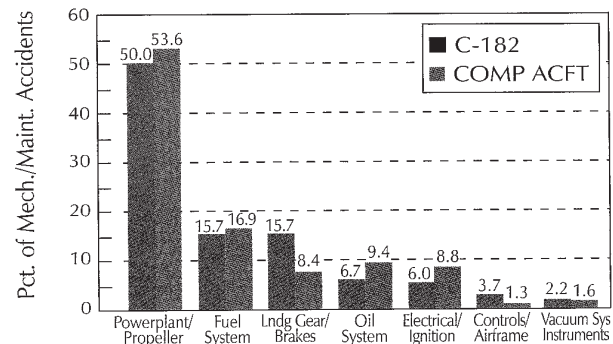
Figure 7. System Involvement C-182

C-182	67	21	21	9	8	5	3
COMP ACFT	165	52	26	29	27	4	5

Of the 134 Cessna 182 and 308 comparable aircraft mechanical/maintenance accidents, approximately 50 percent of each were due to powerplant/propeller issues. (See Figure 7). The fuel system and the landing gear/brakes caused 15 percent of the mechanical Skylane accidents each. However, with only

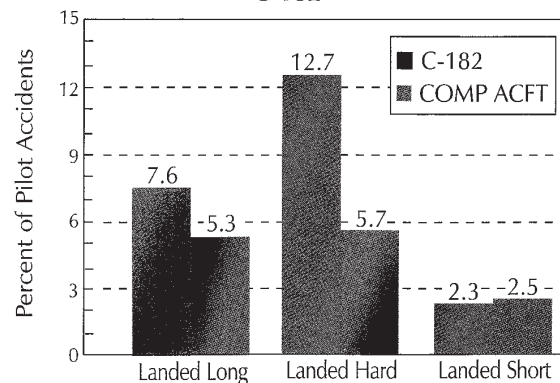
Figure 10. Critical Phase of Flight—Landing
C-182

C-182	80	134	24
COMP ACFT	130	138	61

Landing is the most accident-prone phase of flight for Cessna 182s and comparison aircraft, with 39 percent and 29 percent, respectively. For the 182, landing hard was the leading transgression. The Skylane had considerably more accidents landing hard than did the comparison group (12.7 percent of pilot-related C-182 accidents, compared to 5.7 percent). (See Figure 10). This may be due to the heavy feel of the elevator control, especially for pilots transitioning to the Skylane from lighter airplanes. Substantial trim is required during landing, but don't trim so much that you will not be able to handle a go-around. Trimming for 75 knots will require you to hold back pressure during landing, but won't require so much forward pressure on the controls during a go-around.

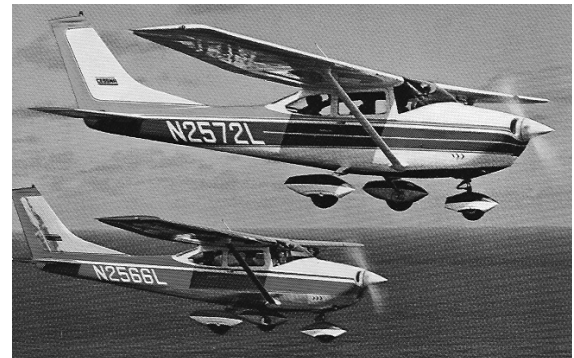
1968 Cessna Skylane & 182

1. Pre-select flap control.
2. Redesigned instrument panel to "T" configuration and three inch gyros.
3. Spool type aileron control system replaces chain and sprocket drive.
4. Fuel strainer control relocated under cowling next to oil dipstick.
5. Ten degrees of flaps permitted below 120 knots.
6. Optional control wheel mounted map light.
7. Two post lights installed on lower control pedestal to illuminate the trim controls, cowl flap control and the fuel selector valve.
8. Larger baggage door latch for two finger operation.
9. Restyled passenger door handles.
10. Noise filter in flap motor circuit with factory installed radios.

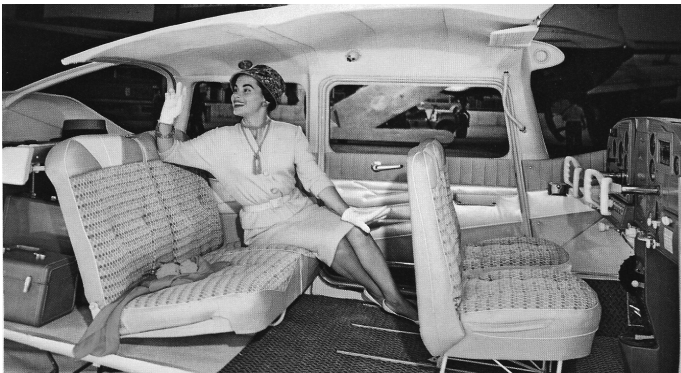
1962 182/Skylane interior

In 1962 the 182 SKYLANE underwent major changes that separated it from the Cessna 180. Among the changes were widening the fuselage four inches, lowering the floor, installing a rear window, electric flaps replacing manual flaps, utilizing a fixed horizontal stabilizer and a trim tab on the elevator instead of the adjustable stabilizer used previously and gross weight went from 2650 lbs to 2800 lbs.

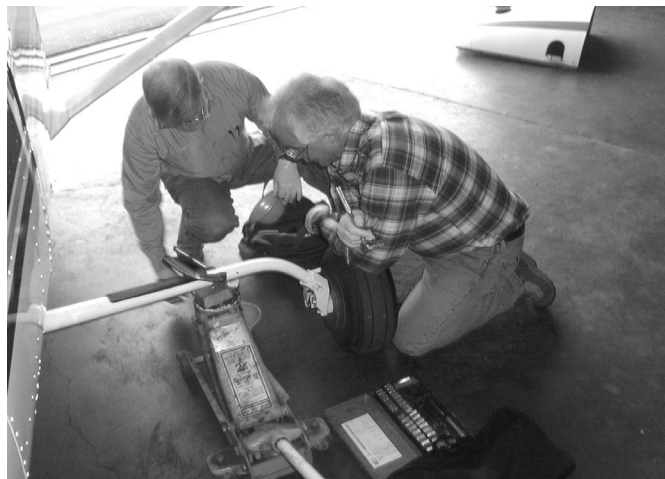
CPA Tech Rep Tom Carr demonstrates correct jacking procedure for an aircraft inspection to Tom Freeman, CPA member.
